## MEMORANDUM

**Project:** 090557-01

**Re:** Post-TCRA Quarterly Inspection Report – October 2013 Inspection

This document reports the results of the October 2013 quarterly inspection of the armored cap cover, fencing, and signage installed for the Time Critical Removal Action (TCRA) at the San Jacinto River Waste Pits Superfund Site (TCRA Site). Figure 1 shows the location of the TCRA site.

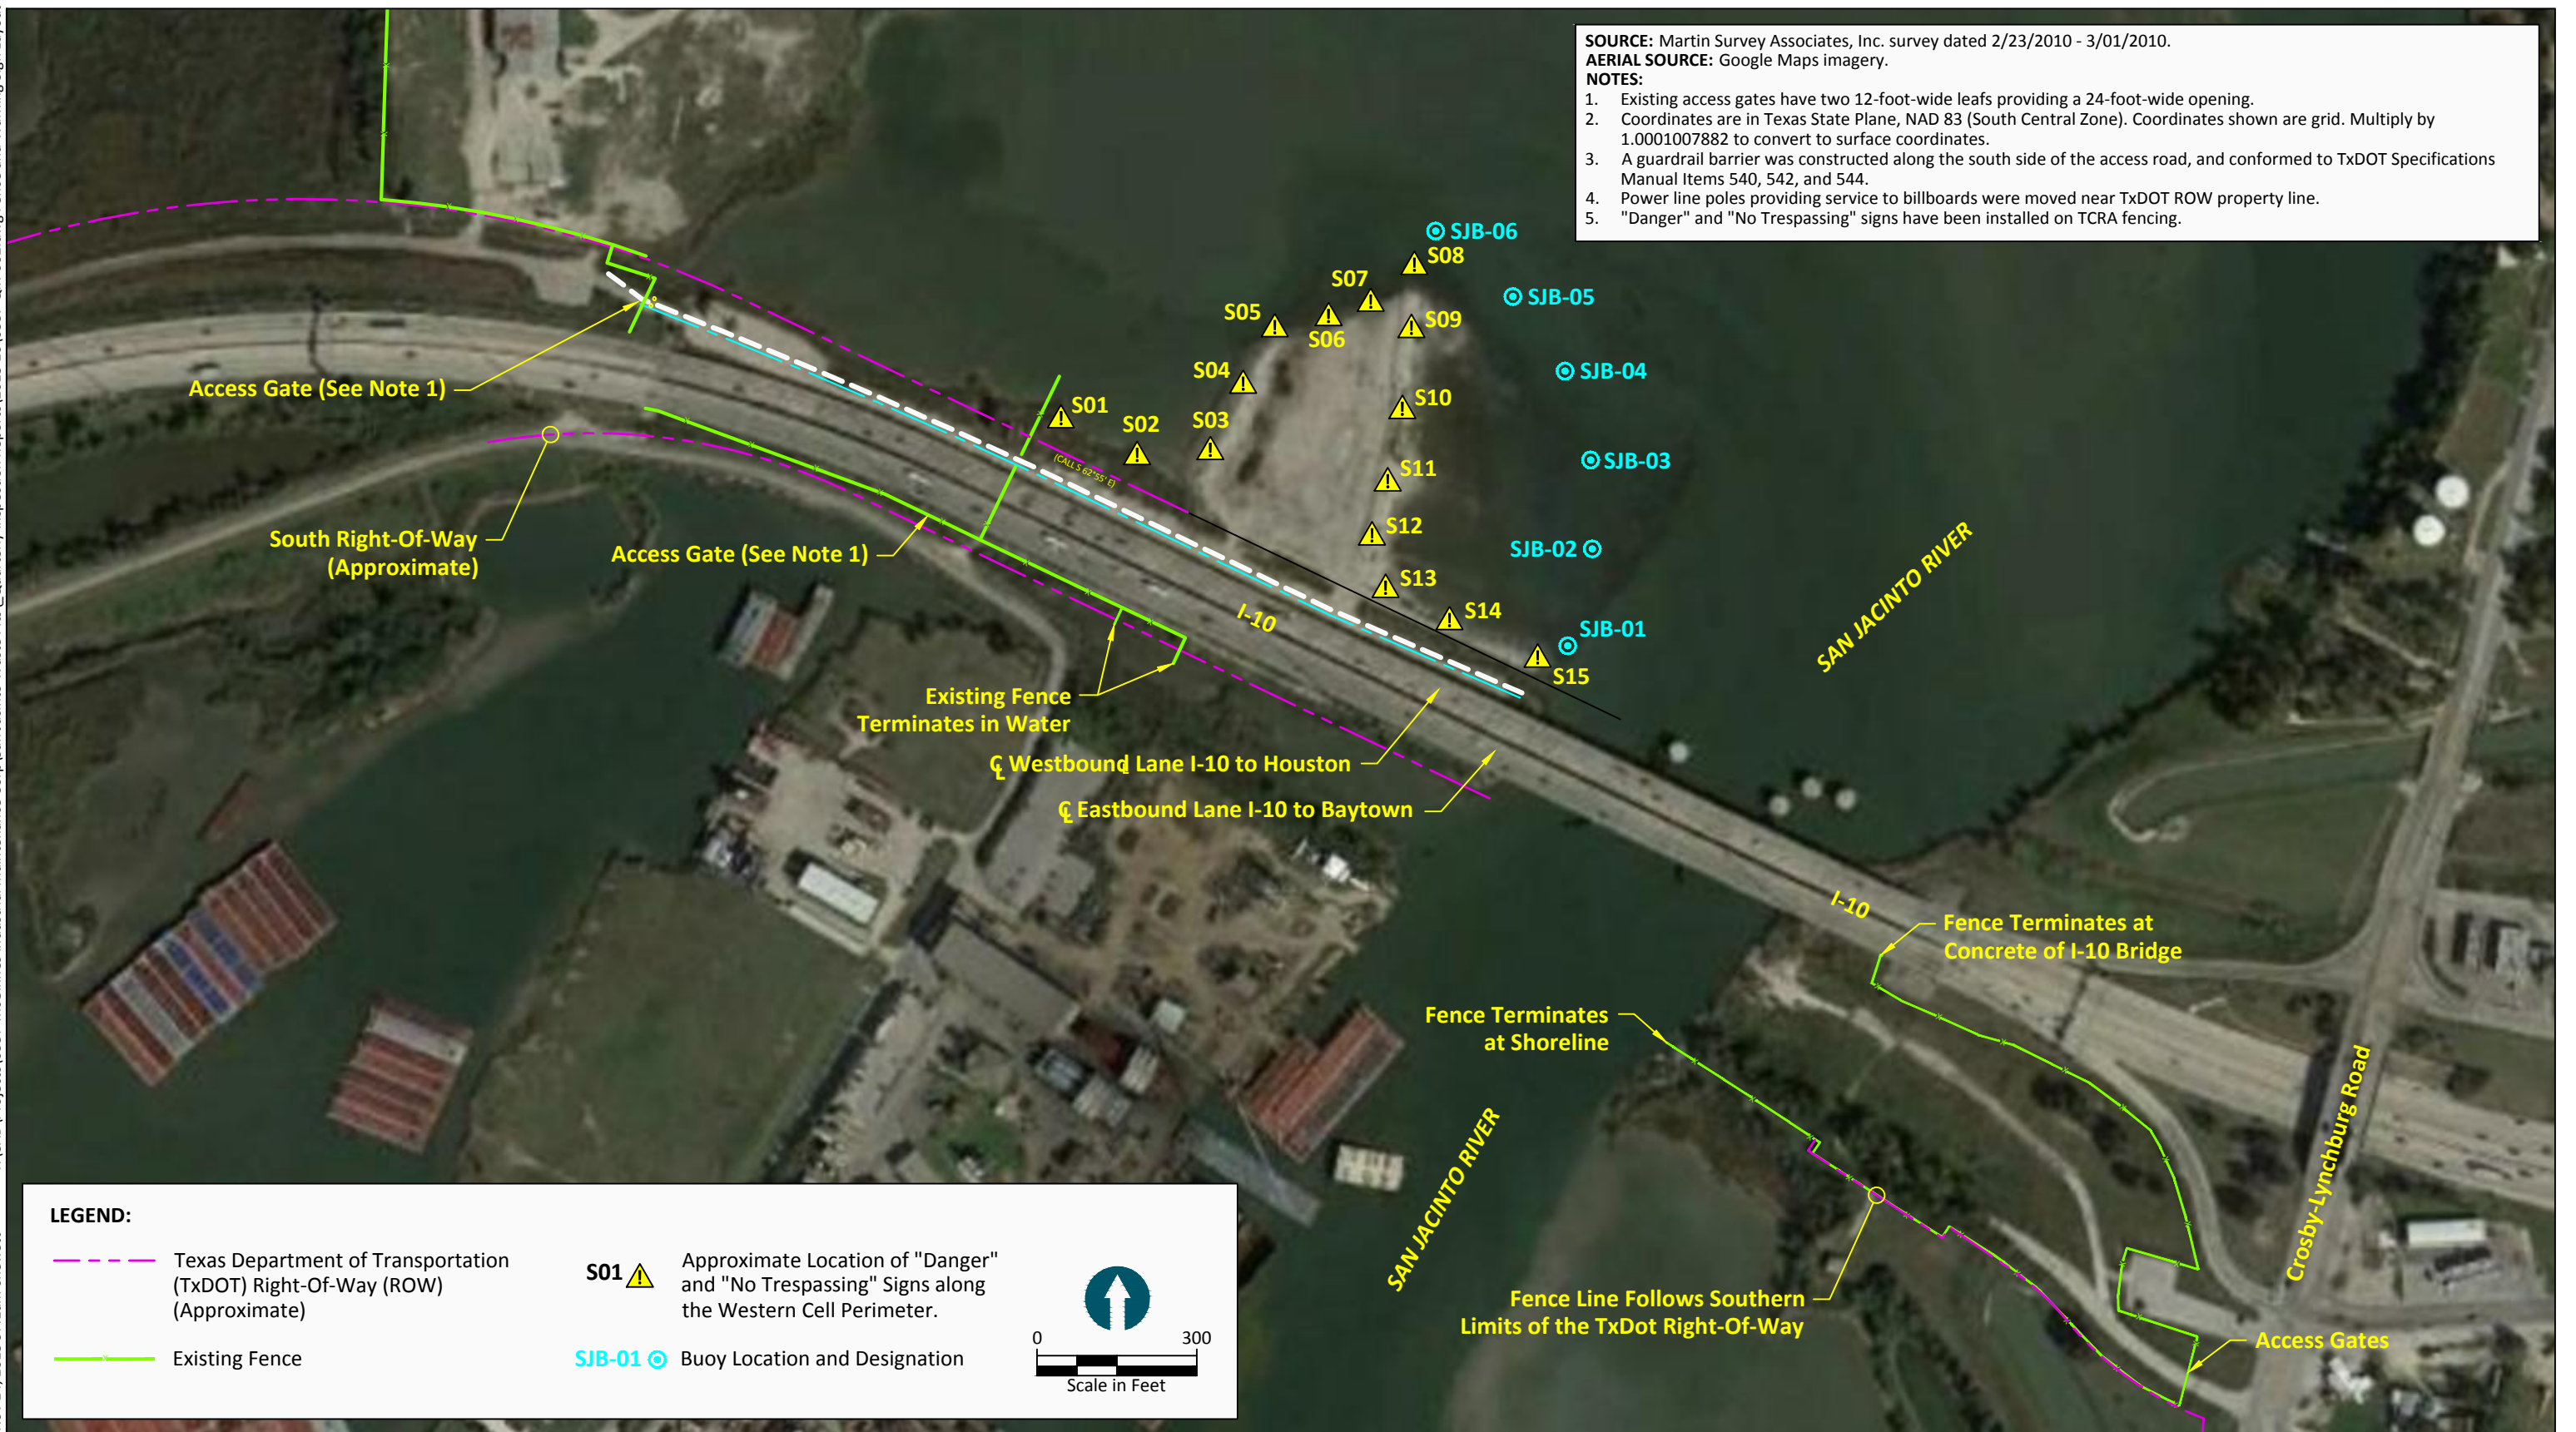
The perimeter fencing (Figure 2) on the west and east banks of the San Jacinto River was visually inspected for breaches or other signs of damage on October 4, 2013. No breaches or other signs of fence damage were observed during this inspection for any of the three sections of the fence: the east bank, the west bank on the north side of I-10, or the west bank on the south side of I-10.

After receiving notification from Texas Department of Transportation (TxDOT) representatives that the fence had been cut on the south side of the east bank, a second inspection was performed on October 16, 2013. The fence maintenance contractor repaired the fence on October 23, 2013, and it was inspected on October 24, 2013. Photographs 14 and 15 show the damage and repairs, and are included in Appendix A. TxDOT staff continues to inspect the gates and fences and to patrol the area for trespassers. The vegetation along the southwest fence alignment facing Market Street has been mowed, and is dying off for the winter.

Other than the cut fence, no other TCRA construction elements were identified as deficient or damaged during this inspection event. Repairs to the fence were made; photographs of

the repaired fence are included in Appendix A. No maintenance was required to the TCRA cap in response to the October 2013 inspection.
